Chip Errata for the i.MX 6ULZ

This document details the silicon errata known at the time of publication for the i.MX 6ULZ multimedia applications processors.

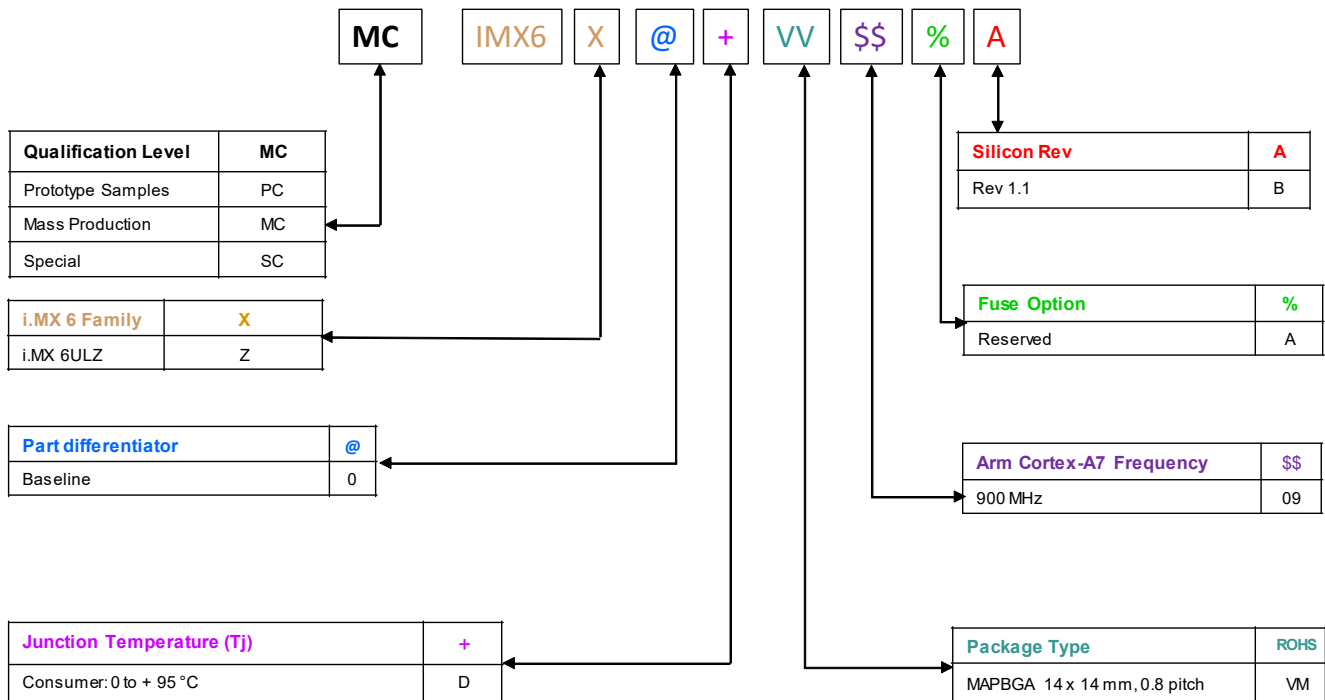
Figure 1 provides a cross-reference to match the revision code to the revision level marked on the device.

Figure 1. Revision Level to Part Marking Cross-Reference
